Inspection Report

Minerals Regulatory Program

Mine Name: Milehigh 1	Permit Number: S/023/0060
Operator Name: William Chirnside	Inspection Date: October 13, 2010
Inspector(s): Wayne Western and Jerry Mansfield	Time: 3:00 – 3:20 pm
Other Participants: None	Mine Status: Active

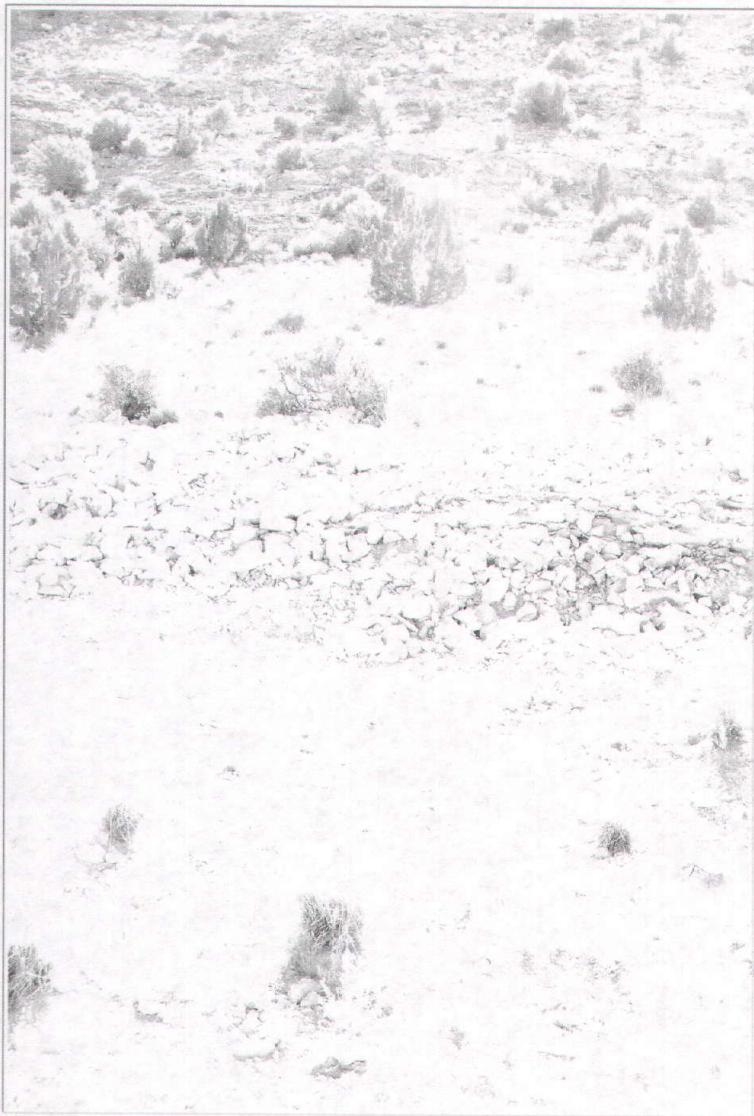
Pit

The site consists of a small pit that is approximately 6 feet deep that has since been partially filled in. The disturbed area is approximately 0.2 acres. Most of the overburden has used to backfill the pit. No topsoil or growth medium was placed over the backfill. Most likely little or no topsoil was present at the site before mining occurred. The area appears to be stable, and there are no signs of erosion. No equipment is stored on site.
